# SERVICE LETTER

CRJ700/705/900/1000-SL-21-029

**SUBJECT:** Cockpit Noise

**MODEL:** CL-600-2C10 (CRJ700), CL-600-2D15 (CRJ705), CL-600-2D24 (CRJ900) and CL-600-2E25 (CRJ1000)

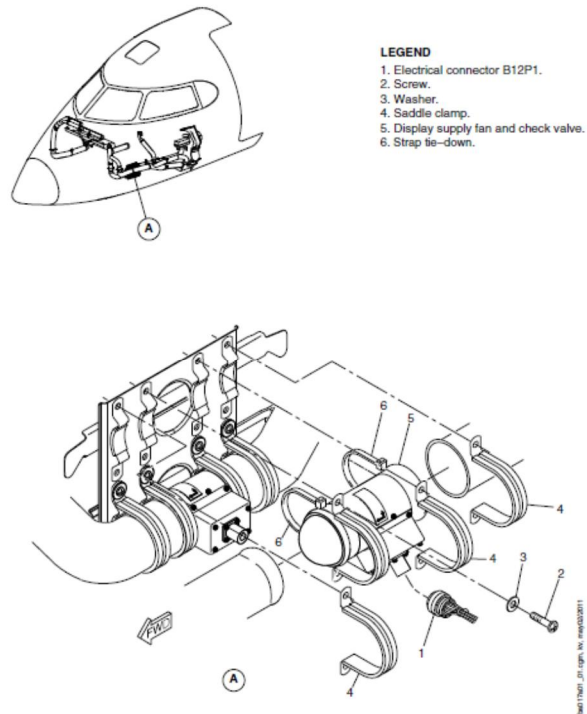
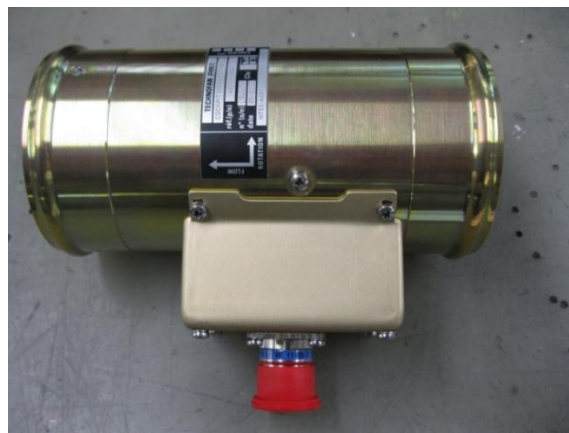
Figure 4: Display Cooling Fan

“NORM” (Ground FAN#2) or “GND ALTN” (Flight FAN#1), then the identified fan must be replaced per AMM task 21-24-12-000/400-801. Refer to figure 4.

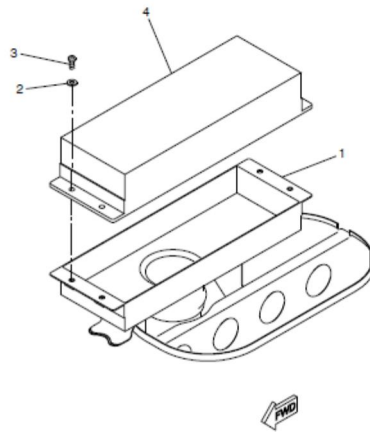
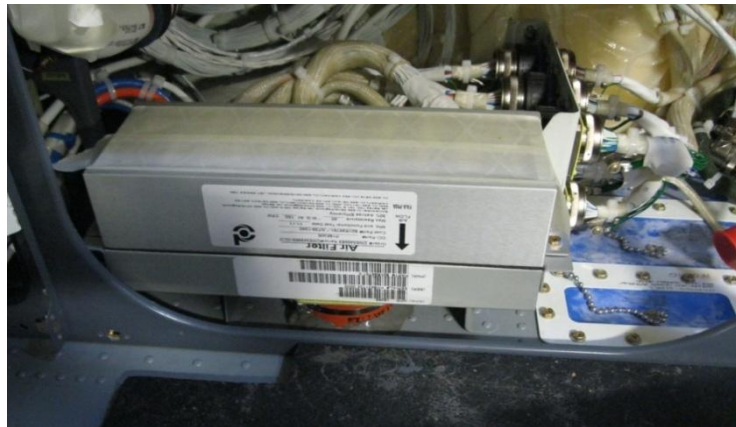
Figure 5: Display Cooling Air-Filter

1. Do a general visual inspection (GVI) on the display cooling air-filter. If found clogged/dirty, replace the filter per AMM task 21-24-10-000/400-801. Refer to figure 5. Re-measure the noise level in the cockpit. If there was no reduction in the noise level then go to step 2, below.

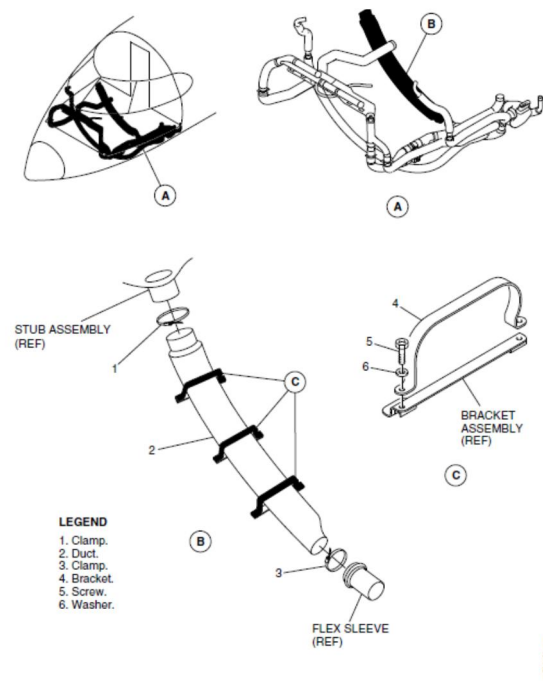
Figure 6: Below-Floor Right-Riser Supply-Duct FS276.25-Removal/Installation

2. Do a complete inspection of the following ducting:  
Refer to figures 6 to 13. If there are any disconnections, reconnect as per the AMM Tasks 21-24 XX. If there are any damaged ducts replace or repair them.

***Note: It is very important to make sure that all ducts are supported and correctly secured per the AMM, if not ducts may vibrate excessively and may be the source of additional noise.***
