SERVICE LETTER

CRJ700/900/1000-SL-30-011 Rev D

SUBJECT: Troubleshooting repeated or persistent L/R WING A/I–Caution Messages (with no associated Maintenance Diagnostic Computer (MDC) message)

MODEL: CL-600-2C10 and or CL-600-2D24 and or CL-600-2D15

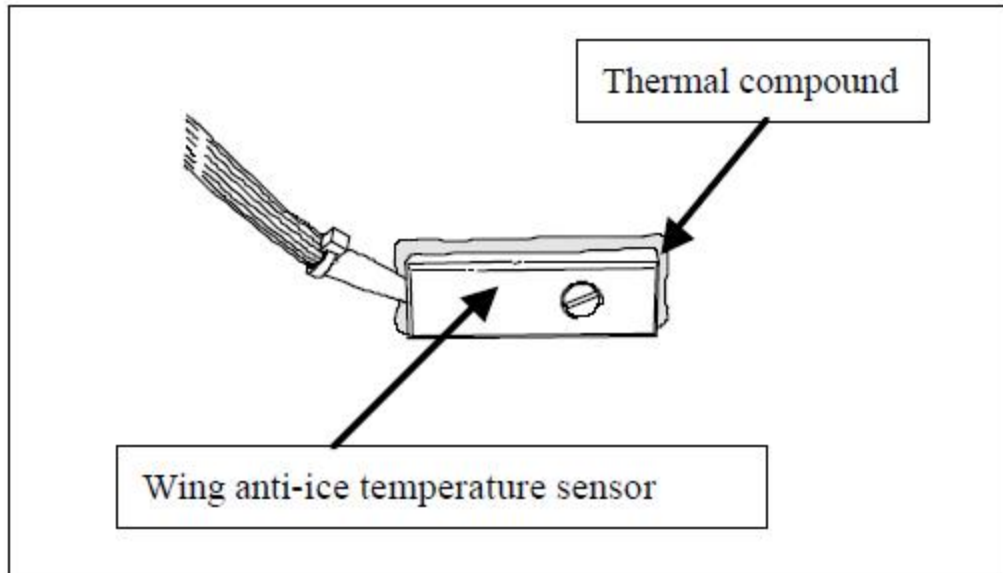
Figure 1. Wing Anti-Ice Temperature Sensor Installation

1. A Low Heat condition in the left and/or right slat (no MDC msg occurs)
2. Insufficient thermal compound on the wing anti-ice temperature sensor (WAITS) leading to a false reading (no MDC msg occurs)
3. A left or right wing anti-ice valve fails closed (MDC msg occurs)
4. Both channels of either the L or R inboard WAITS fail (MDC msg occurs)
Note: Message may have extinguished when crew selected Wing Anti-Ice Cross-Bleed Switch from the non-affected side (AFM and QRH).
5. Both channels of the AILC fail (MDC msg occurs)
6. The harnesses and/or splices of any of the WAITS are damaged (possible MDC msg occurs,)

- When installing a WAITS make sure that an excess of thermal compound squeezes out from around the full perimeter of the sensors. Remove the excess thermal compound; however make sure that a small amount remains visible on all the edges of the sensor. Refer to Figure 1, Wing Anti-Ice Temperature Sensor Installation
- Torque the screws on the sensors from 15 to 20 lbf-in (1.70 to 2.26 N-m).
