SERVICE BULLETIN

MAIN LANDING GEAR SHOCK STRUT PISTON/AXLE - INSPECTION

REVISION NO. 1 – Feb 26/18

49200-32-85 R1

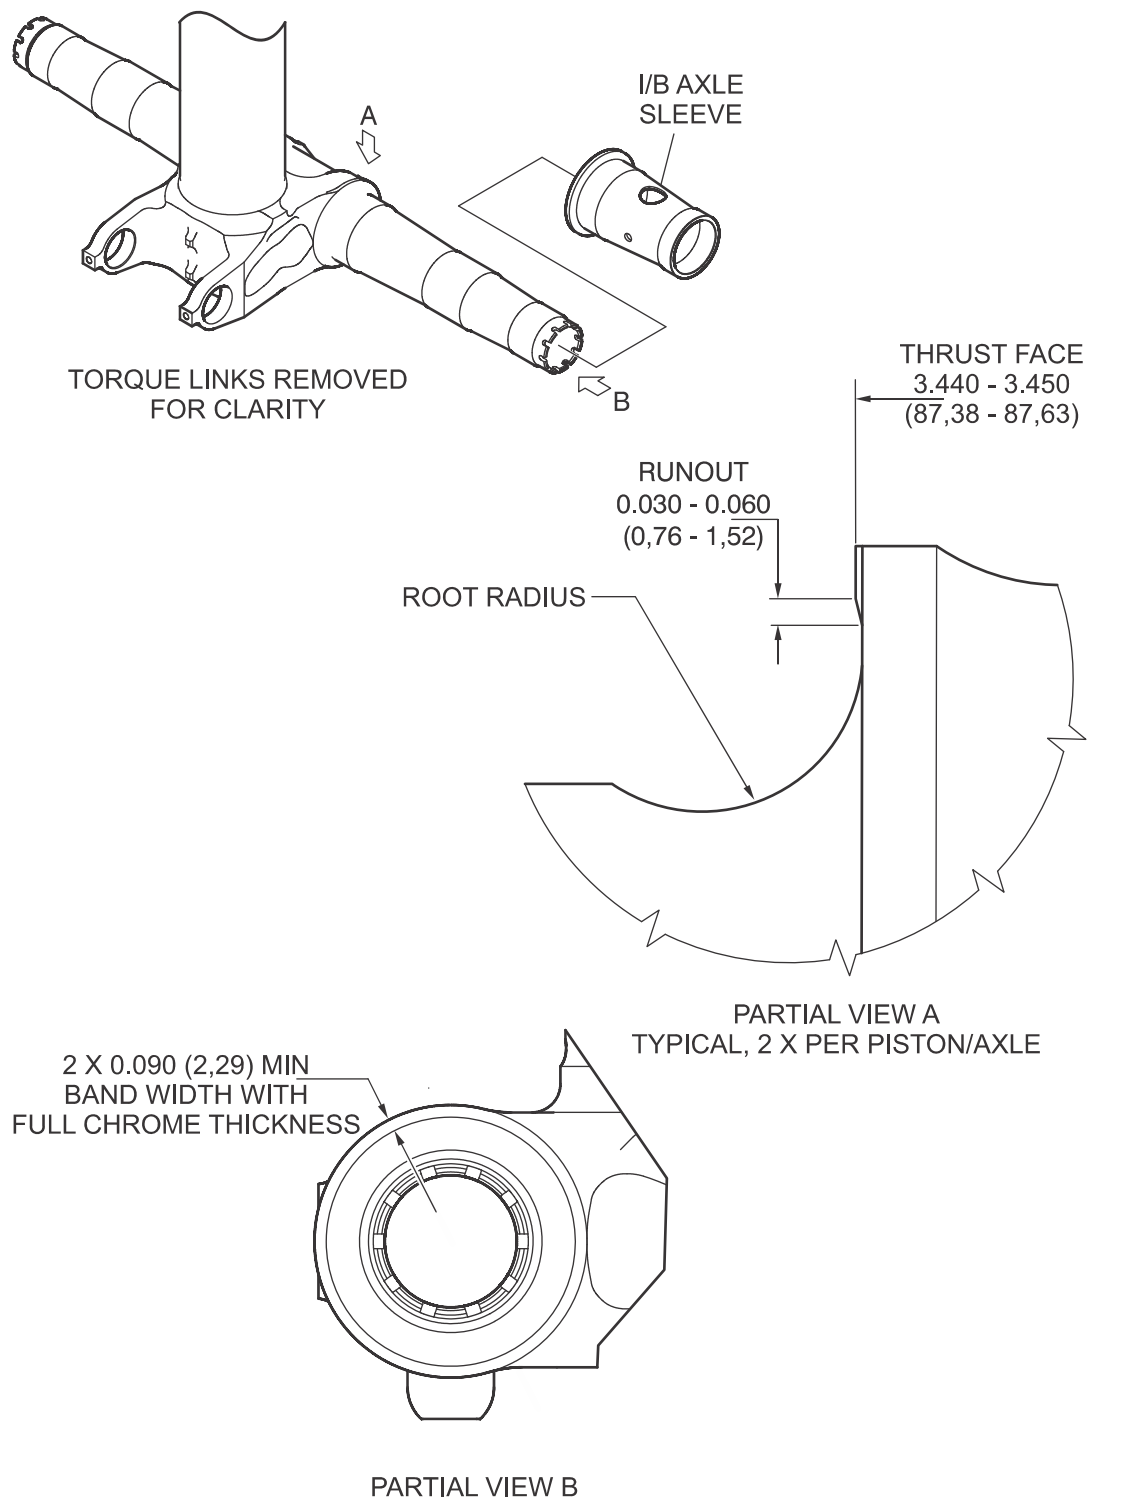
Piston/Axle Inspection
Figure 2

C. Inspection (Ref. Figure 2)

- (1) Inspect piston/axle root radius, thrust face surface and adjacent area.
 - (a) Inspect condition of topcoat, primer and cadmium plate for freedom from damage with no missing paint or exposed base material.

NOTES 1. Primer/topcoat must overlap the chrome plate runout.

2. If paint is not visible or base material is visible, inspect for evidence of corrosion.

- (2) If no damage is found, assemble and re-identify in accordance with paragraph D and paragraph E.
- (3) If damage or corrosion is found, refer to aircraft manufacturer's appropriate documentation.
