Doc.-Number: IS67034440079 **Rev. No.:** C **Issue:** 0 **EO-Date:** 07.06.11 **Page** 1 of 7

Title: Radio Altimeter Antennas Alternate Conductive Gasket

ATA Chapter: 34

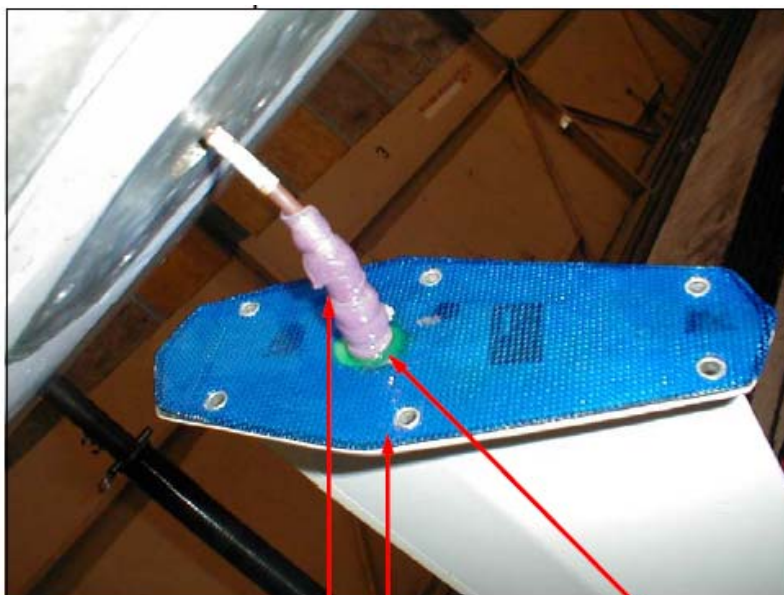
Figure 2: General Antenna installation

StretchSeal Tape on connector
Antenna Gasket in place on antenna
HT3326-5 Self-Leveling Green Sealant applied to connector base

- 4.1 Remove the StretchSeal Tape P/N: AD89503-01-36 from the package and unroll a small length of tape. Pull back a small amount of the release film, making sure that the tape remains free of dirt or other contaminants.
- 4.2 From the inside of the aircraft, wrap the sticky side of the sealing tape around the mated connector with a 50% overlap while stretching it to ensure a tight wrap. Remove release film as required.

The sealing tape will be easier to install this way. (Refer to Figure 2)

- 4.3 Apply cable ties (MS 3367 type) at each end of tape. Use minimum tension on cable tie installation tool (Ref. to Figure 2).
