## SRM – EXAMPLE

### D-AISC AIRBUS A321-200

**Damage:** Scratch on L/H Forward Passenger Outer Door Skin in lower aft corner.

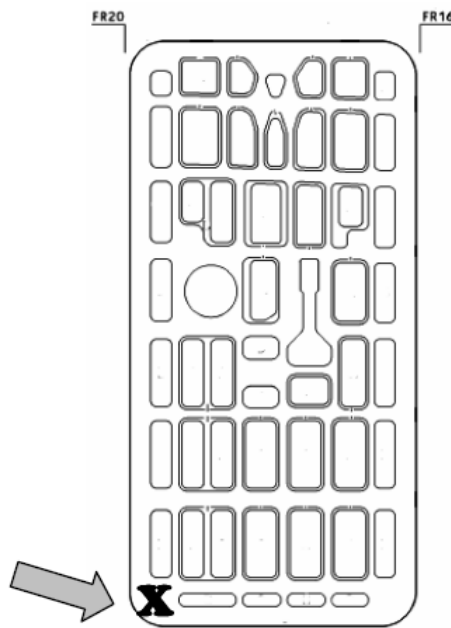
Damage depth: 1,2mm / 0.047inch

Damage length: 25mm / 1inch

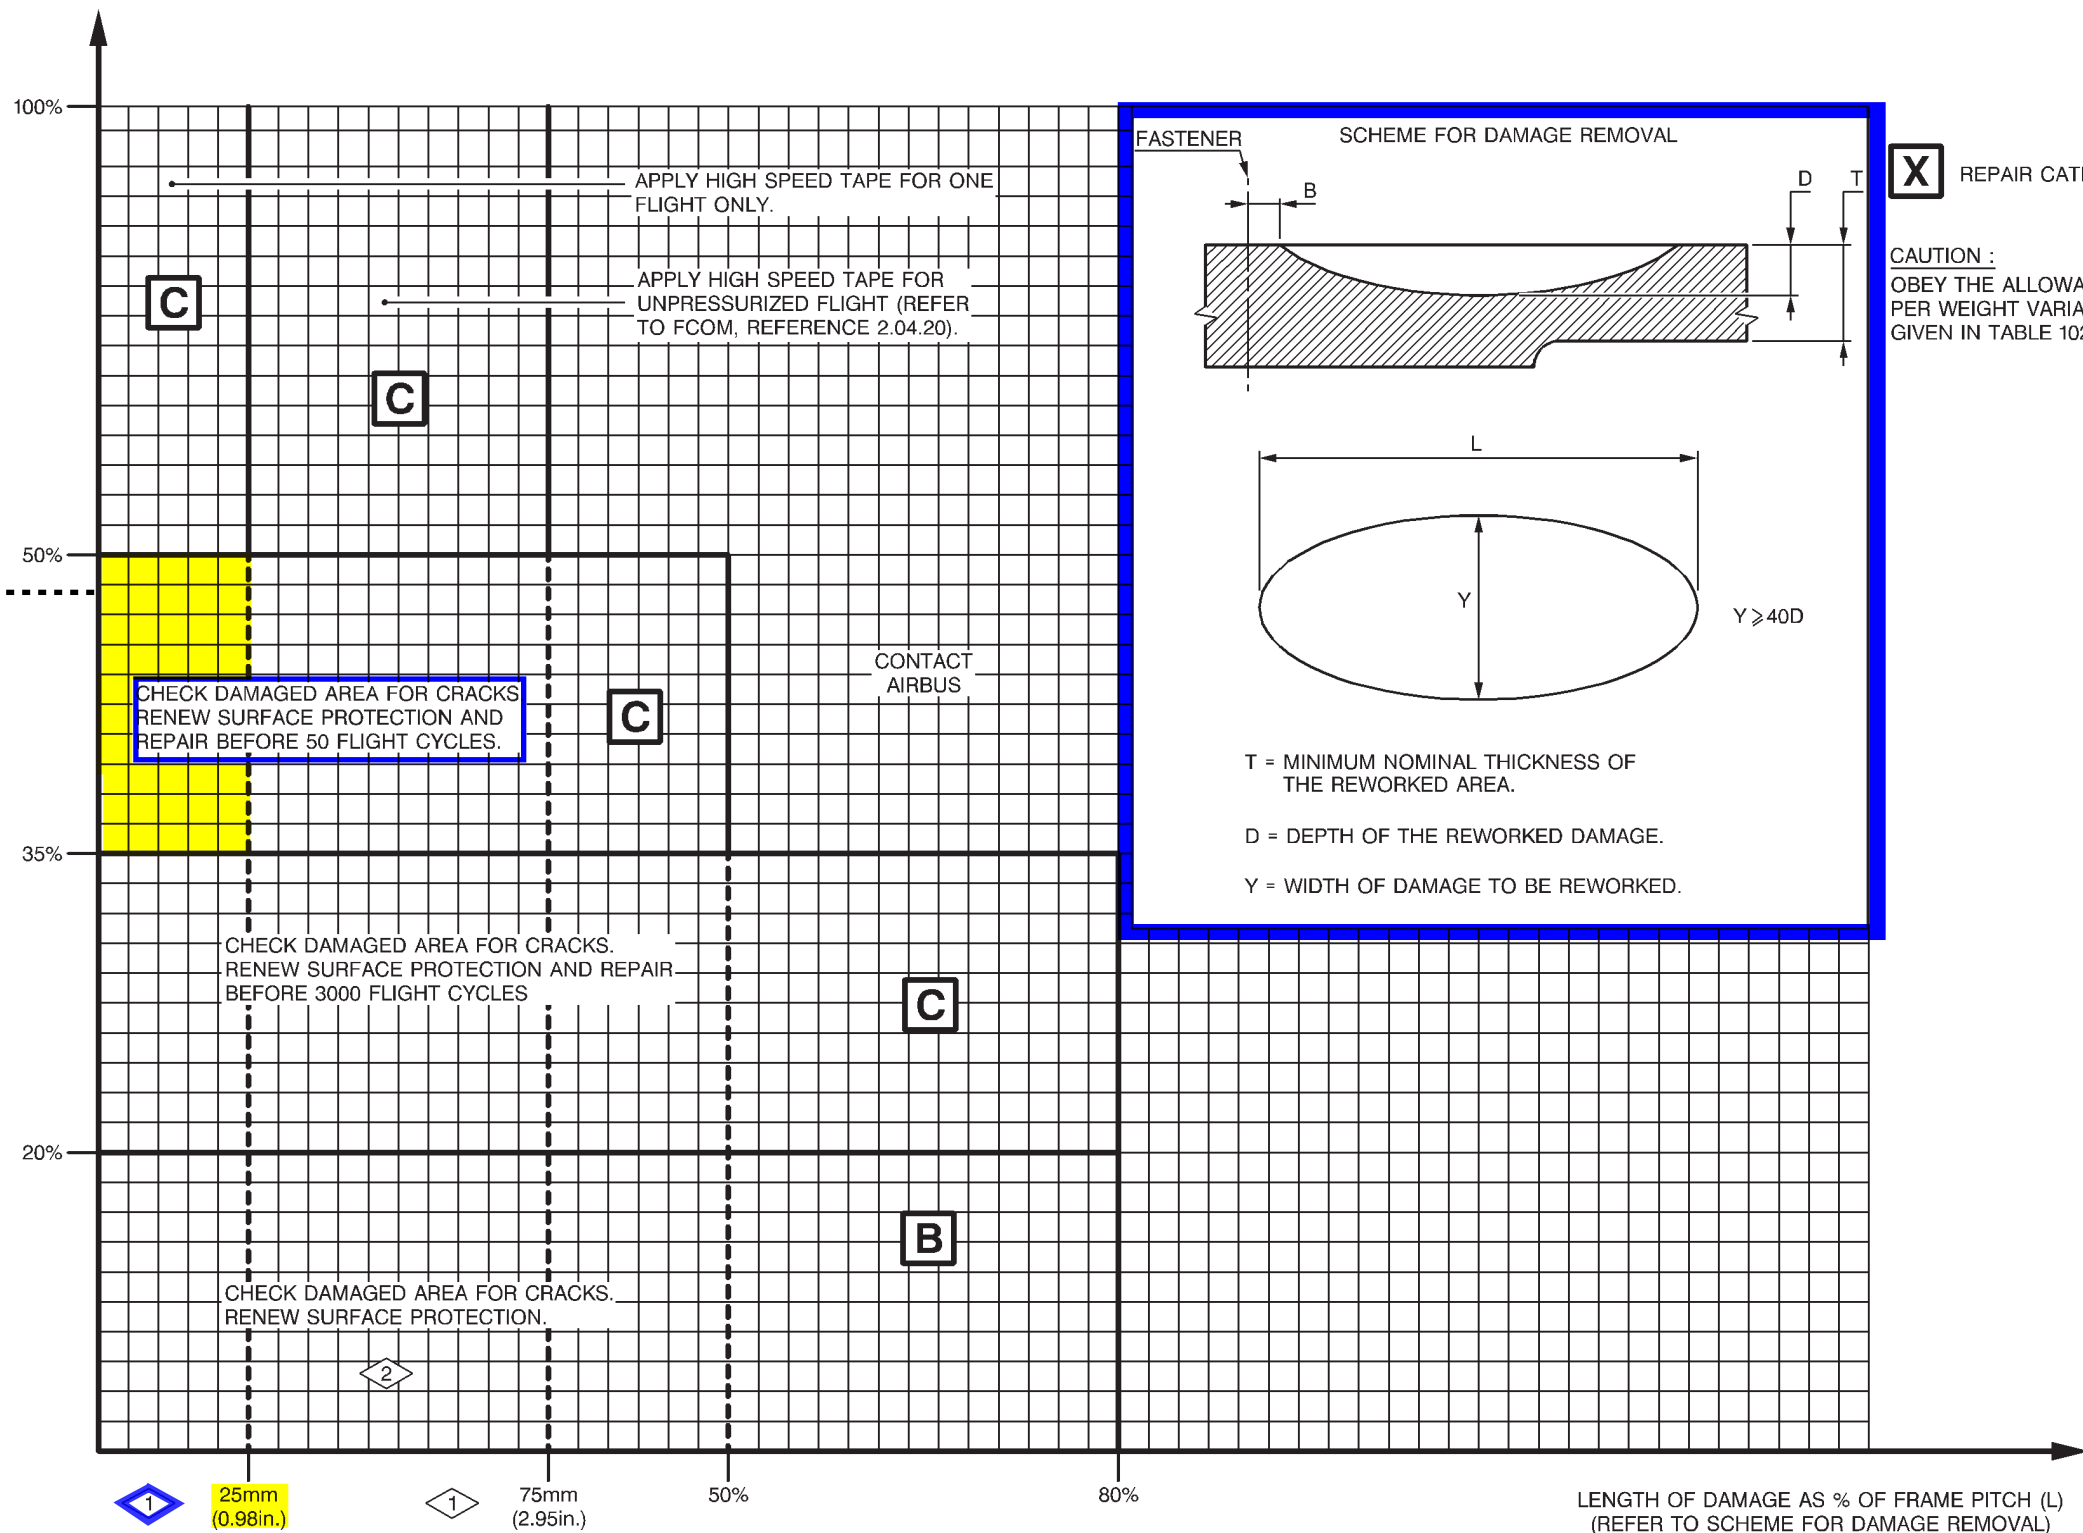
**Figure 101**

Damage Depth=1,2mm  
Skin Panel Thickness= 2,5  
Depth of Damage is 48%
