# SERVICE LETTER

CRJ700/705/900/1000-SL-21-029

**SUBJECT:** Cockpit Noise

**MODEL:** CL-600-2C10 (CRJ700), CL-600-2D15 (CRJ705), CL-600-2D24 (CRJ900) and CL-600-2E25 (CRJ1000)

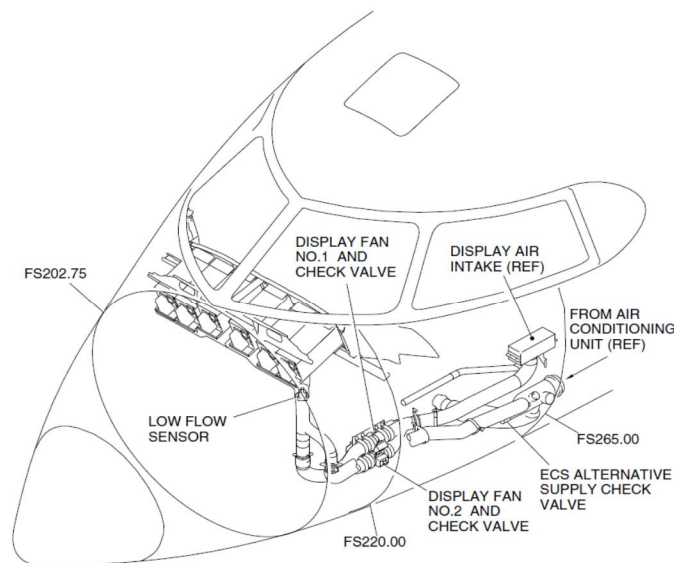
Figure 1: Display Cooling System

The line replaceable units (LRU) of the display cooling system are (See figure 1):

- The display fan and check valve (No. 1)
- The display fan and check valve (No. 2)
- The display air filter
- The environmental control system (ECS) alternate supply check valve
- The low flow sensor (LFS), and
- The low pressure ducting which connects the LRUs.

1. Replacing the display cooling filter when it is (partially or fully) clogged.
2. Using the alternate display cooling fan or replacing a noisy fan.
3. Reconnecting disconnected display cooling ducts.
4. Replacing or repairing of damaged display cooling ducts.

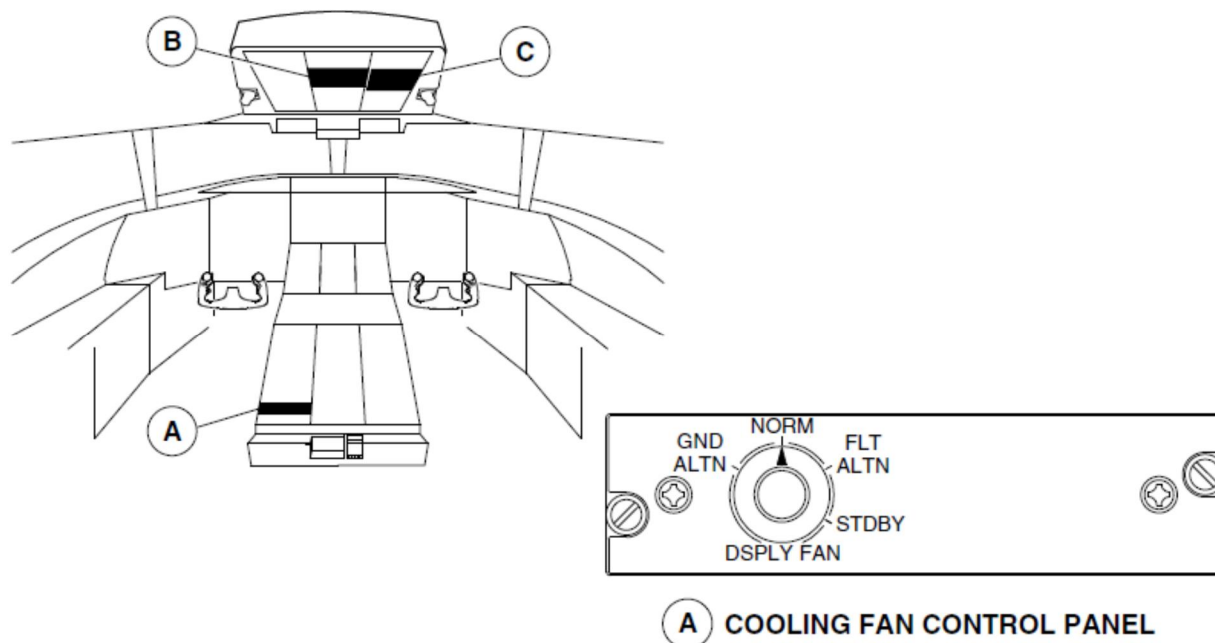
Figure 2: Cooling Fan Control Panel

The display fans (No. 1 and No. 2) are activated from the cooling fan control panel located on the center pedestal as shown in figure 2. These fans operate one at a time and pull air from the cockpit through the display cooling filter. The filter is located on the floor on the left side of the cockpit.

The GRD ALTN position energizes the flight fan on ground. In NORM position the ground fan and flight fan operation is controlled as a function of weight on wheels (WOW). The FLT ALTN energizes the ground fan in flight. While in the STDBY position, the ground fan and the flight fan are de-energized and conditioned air from the left air conditioning duct supplies ventilating air. This filter removes air borne particles from the air within the cockpit before the air goes into the cockpit displays. There is no filtering in the STDBY mode,

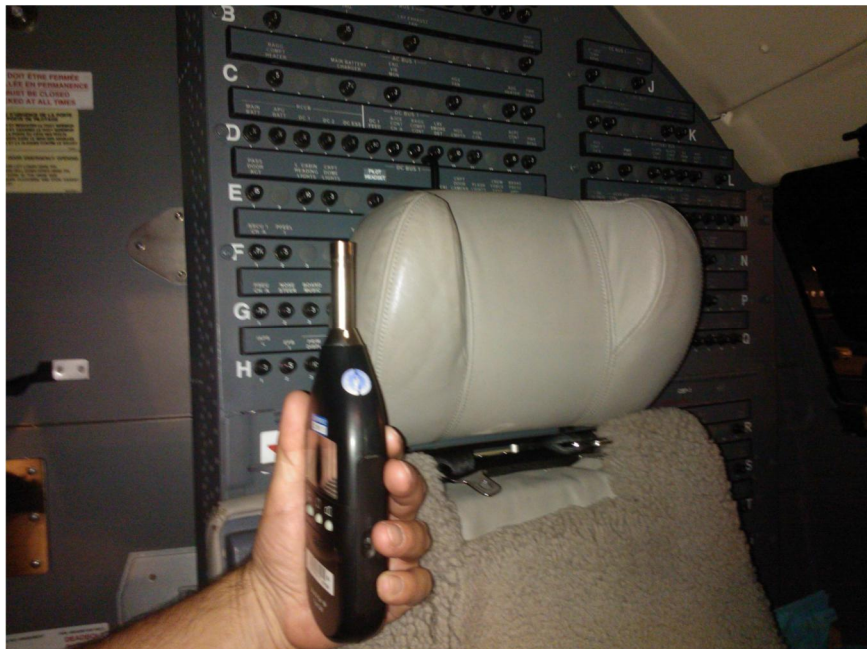
Figure 3: Sound Level Meter Position

**Note:** All noise measurement must be done with a calibrated sound level meter located as shown in figure 3. That is, with the pilot's seat at the lowest and rearmost position and the sound level meter positioned right next to the pilot's headrest.

The R0-1350 sound level meter or equivalent can be used to measure the noise level in the cockpit at the pilot's head as shown in figure 3. Configure the sound level meter as follows:
