# **Airbus**

## **A318/A319/A320/A321**

### **ATA 28**

### **Fuel Tank Safety**

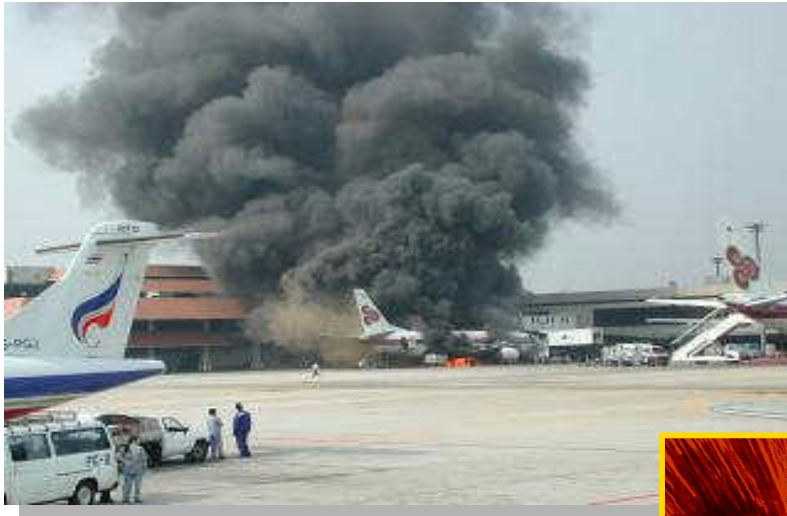
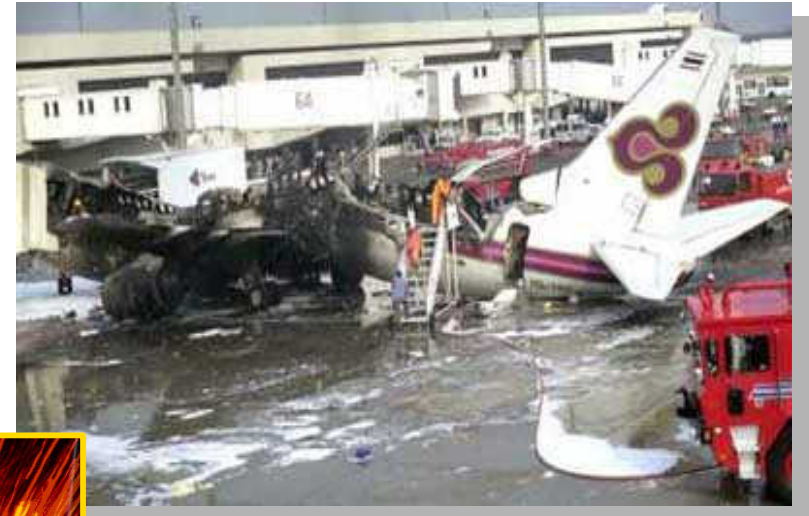
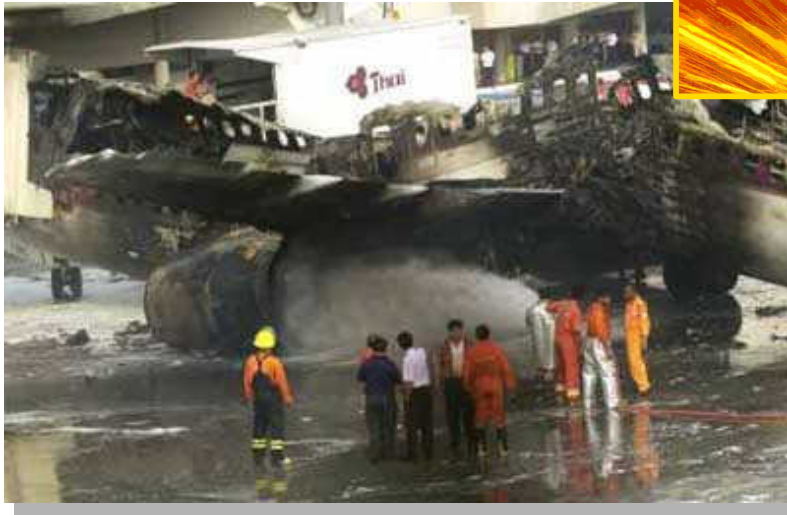
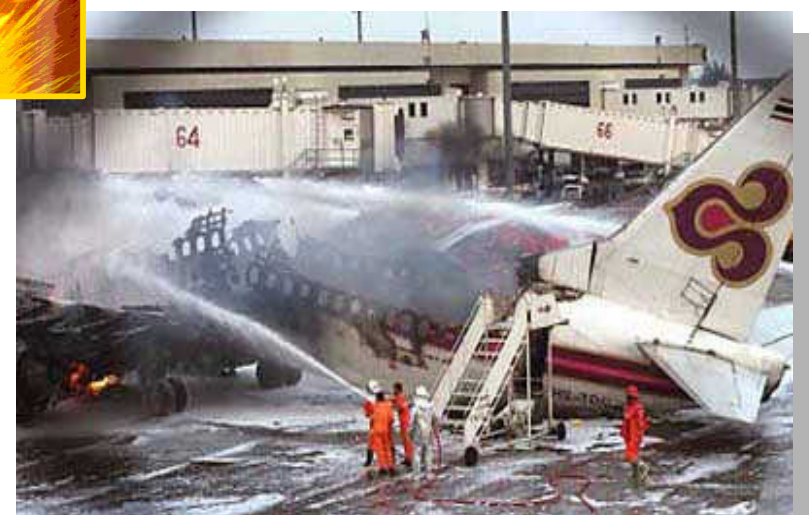
**Figure 2 Thai 737-400 Fuel Tank Explosion**

After investigation, the NTSB has determined that the center fuel tank exploded, shortly after the main fuel tanks were refueled. The cause of the explosion was the ignition of the flammable fuel/air mixture in the center fuel tank. The source of the ignition energy for the explosion could not be determined with certainty, but the most likely source was an explosion originating at the center tank fuel pumps.

**NOTE:** The pumps were operating dry (no fuel passing through them) at the time of the explosion!

**The pumps were operating dry (no fuel passing through them) at the time of the explosion!**

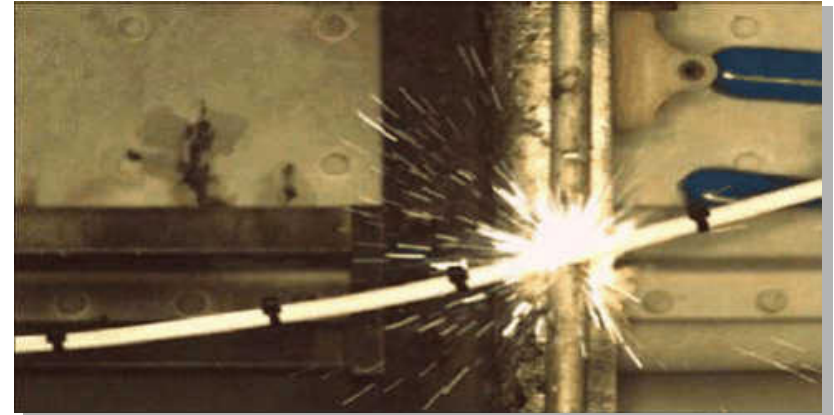
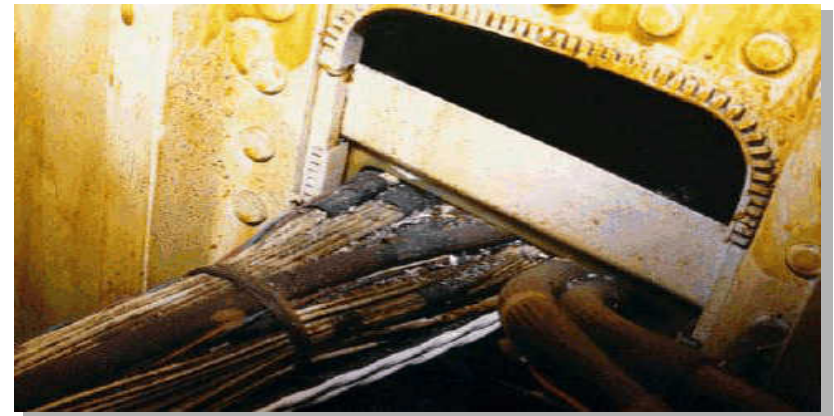
**DRILL SHAVING AND CONTAMINATION ON WIRE BUNDLES****Figure 3 Accident Findings**

**Requirements for ignition of flammable vapors**

**ELECTRICAL ARCING**

The presence of sharp metal shavings, which can be attributed to drilling, can strip insulation away from wires. As a result, the core conducting wires become exposed and enhance the likelihood of a spark. Exposed wires that are coated with „syrup“ or metallic drill shavings can be dangerous because either substance can act as a conductor. Consequently, substances such as these could function as a base point for an electric arc, which could ignite the contents of a fuel tank. The NTSB initiated simulations with these conditions to see if it was possible to create an electrical arc. In one rare case, when bare wires were bundled close to each other, an arc was created.

Another possible source of ignition is from the terminals of the FQIS wires in the central fuel tank on which copper sulfide can build up. This phenomenon has been observed in aging electrical systems, and is a result of the natural deterioration of wiring. The buildups can become sources of localized heat. This can cause a threat because of autoignition. If the localized heat source is hot enough, the fuel around it may reach a temperature at which it will automatically ignite.

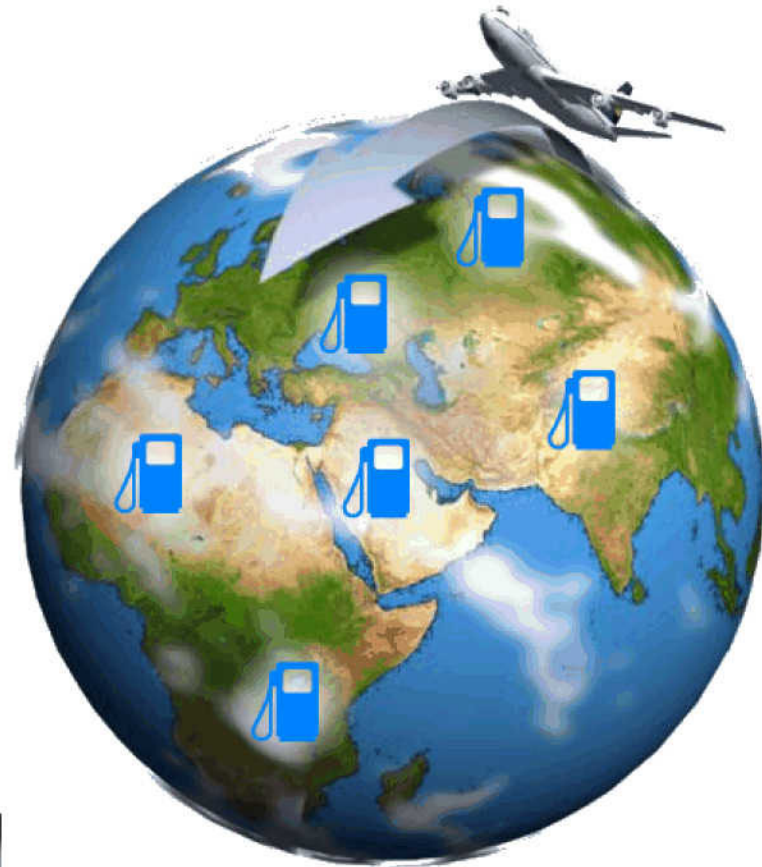
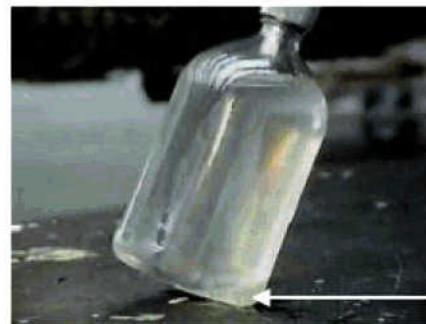
**Water****Figure 14 Fuel Requirements**

**Main Requirements for Turbine Engine Fuel:**

- low Freezing Point
- Flash Point
  - low enough for ignition
  - as high as possible for safe handling
- low tendency to vaporize in high altitudes
- widely available
- low tendency to carry water
- high volatility desirable for engine starts
- available all over the world
- adequate lubrication capabilities
- low tendency to hold water

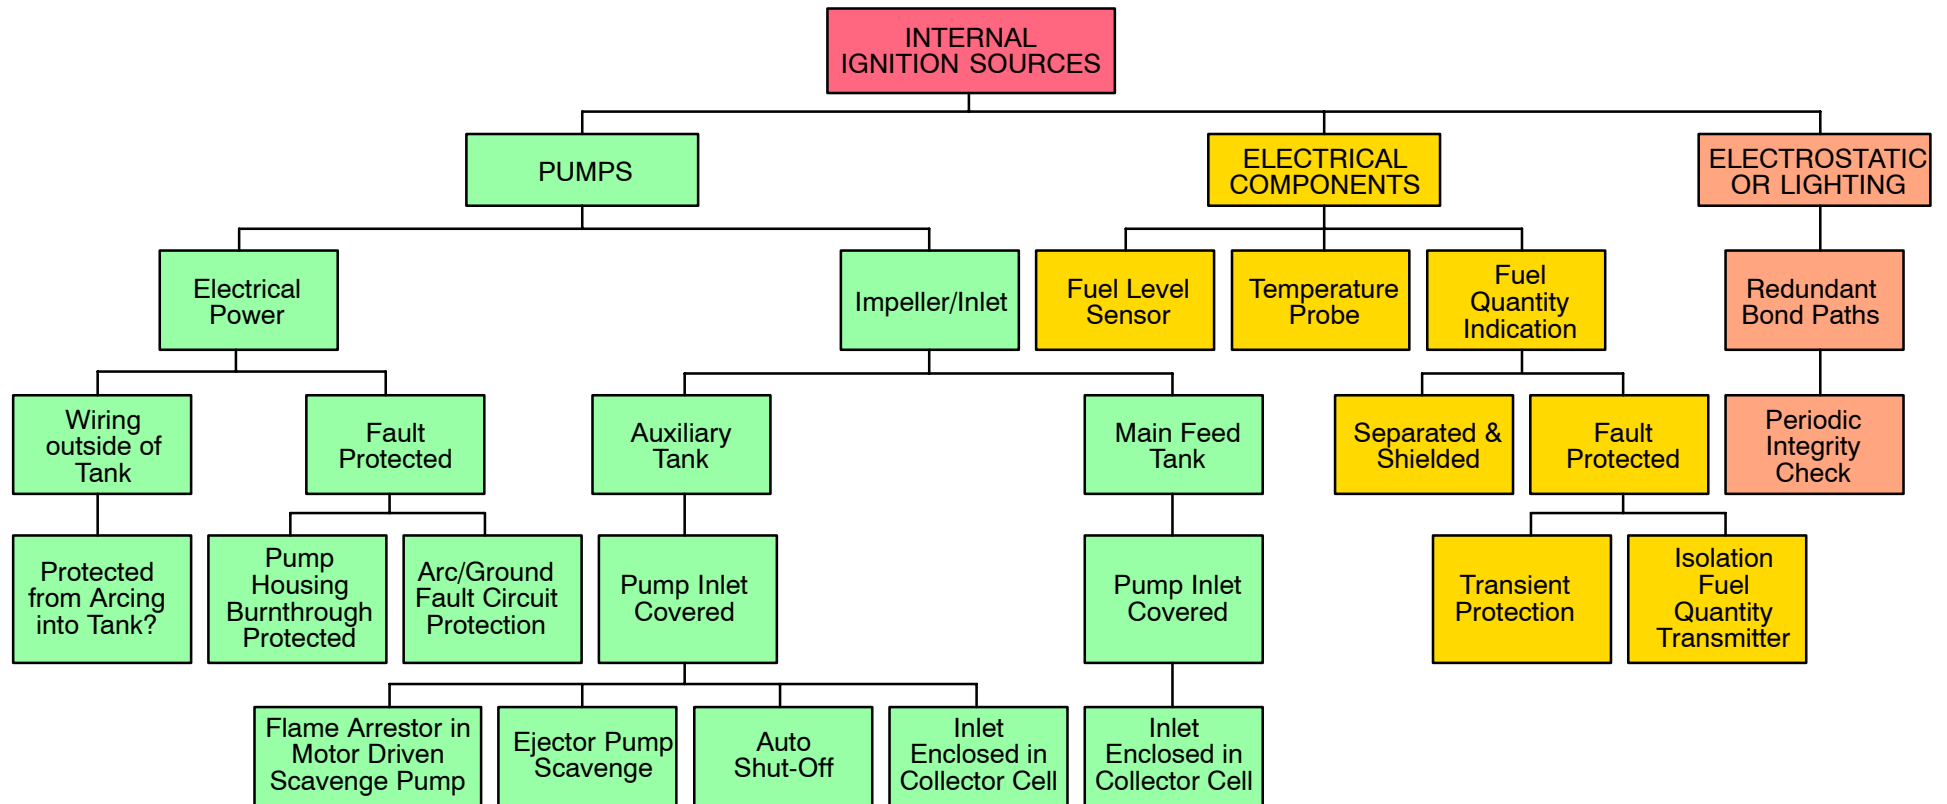
**Figure 15 Internal Ignition Source Consideration**

### Fuel Tank Ignition Source Consideration

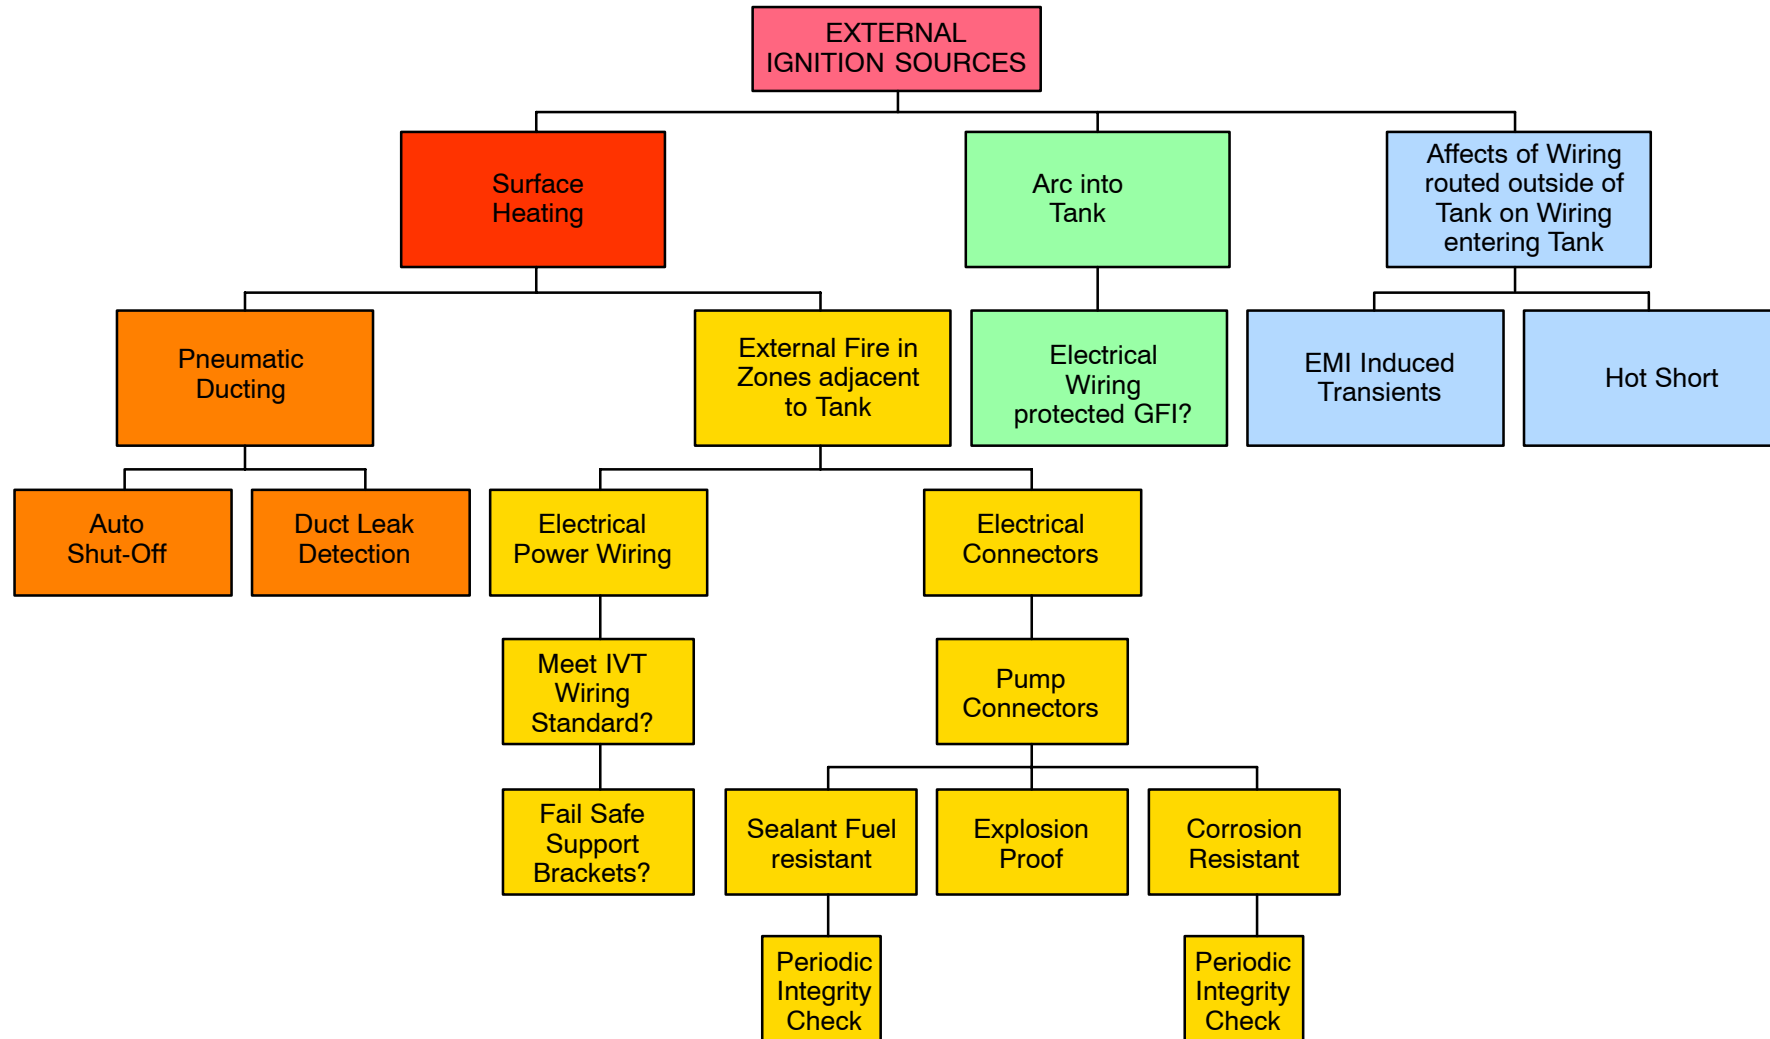
Figure 16 External Ignition Source Consideration

## Fuel Tank Ignition Source Consideration

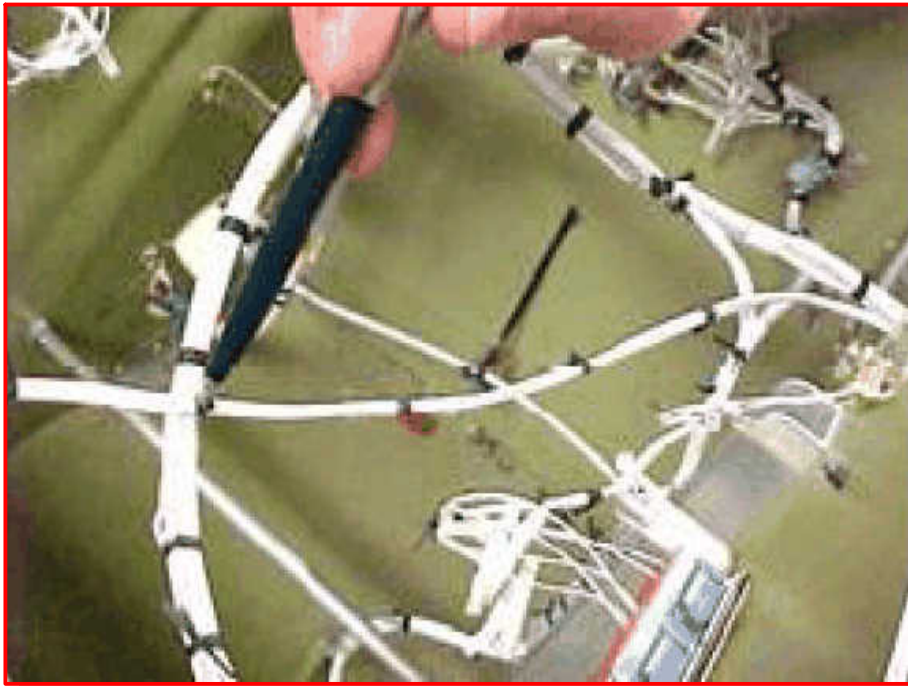
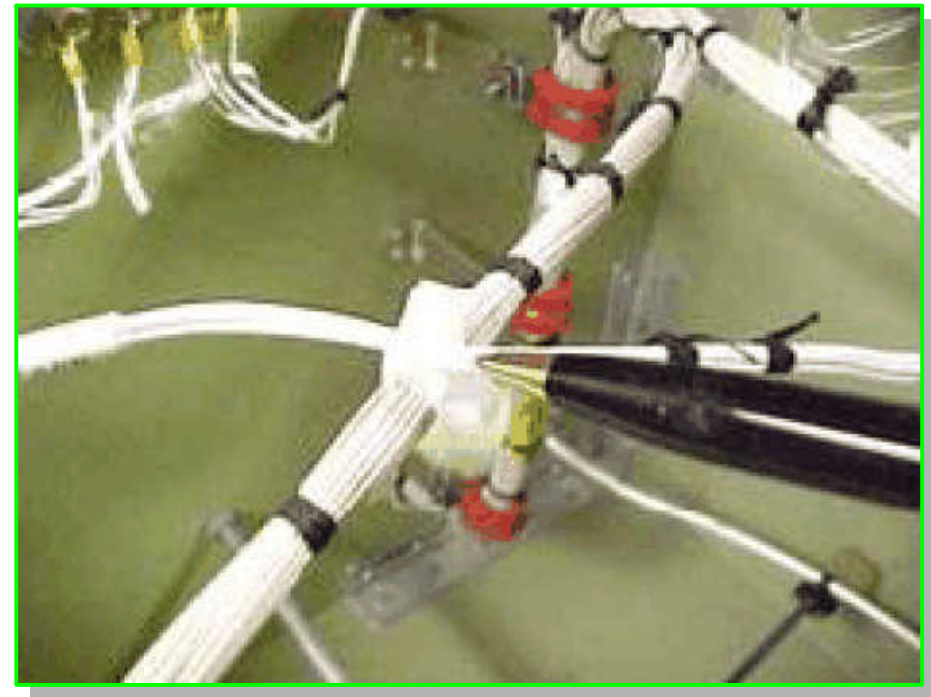
**Figure 20** Wires riding on other Wires

**IMPROPER**

Wire bundles that cross should be secured together to avoid chafing

**PROPER**

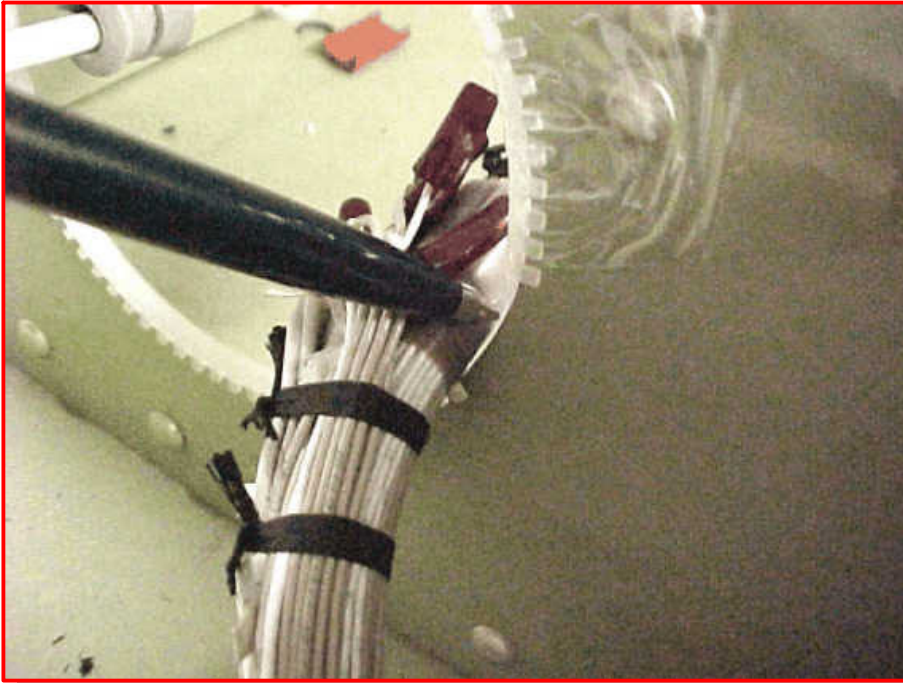
**Figure 21 Wires riding on Lightning Hole**

**IMPROPER**

If the grommet is too short, wire bundle chafing can occur.

**PROPER**

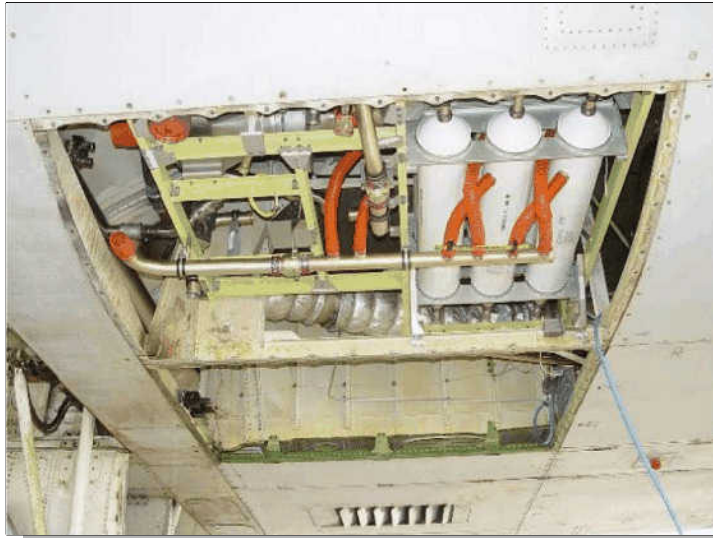
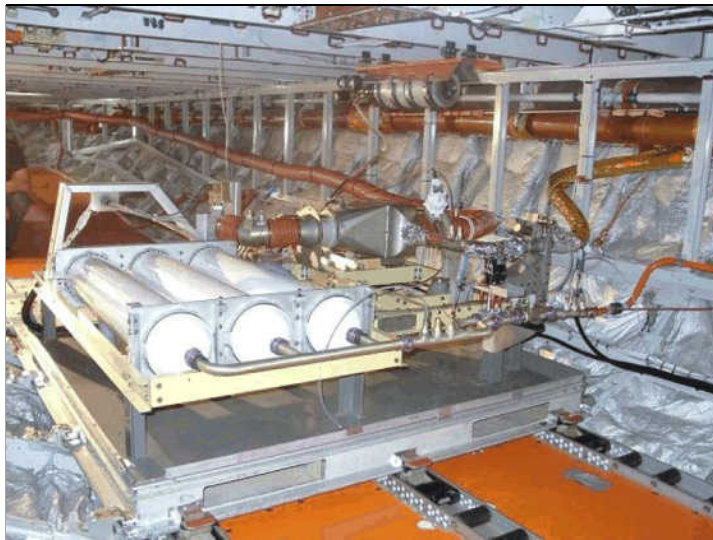
**Figure 23 Flammability Reduction System**

**FLAMMABILITY REDUCTION SYSTEM 747 SP**

**FLAMMABILITY REDUCTION SYSTEM A320 TEST VERSION**

**AIR SEPARATION MODULE (ASM)**

Beside the avoidance of igniting sources, the explosion hazard can be prevented by nitrogen enrichment of the fuel tanks, called FRS (**F**lammability **R**eduction **S**ystems"). The pressurized air in the system is forced through the membrane fibers and allows fast gases to escape through the membrane wall and the nitrogen rich stream to pass through. By this possibility the level of the fuel center tank can be adjusted from "high flammability" to "low flammability".
